Third Semiannual Monitoring (SA3) Report (January – June 2017) and First Annual Periodic Review Report (PRR1) Site Management Plan Monitoring

**Former Clifton Manufactured Gas Plant
Staten Island, New York
NYSDEC Site No.: 2-43-023
Order on Consent Index #: D2-0001-98-04**

**Prepared for:
National Grid, USA
287 Maspeth Avenue, Brooklyn, NY 11211**

**Prepared by:
AECOM
125 Broad Street
New York, NY 10004
Project No. 60137363-600**

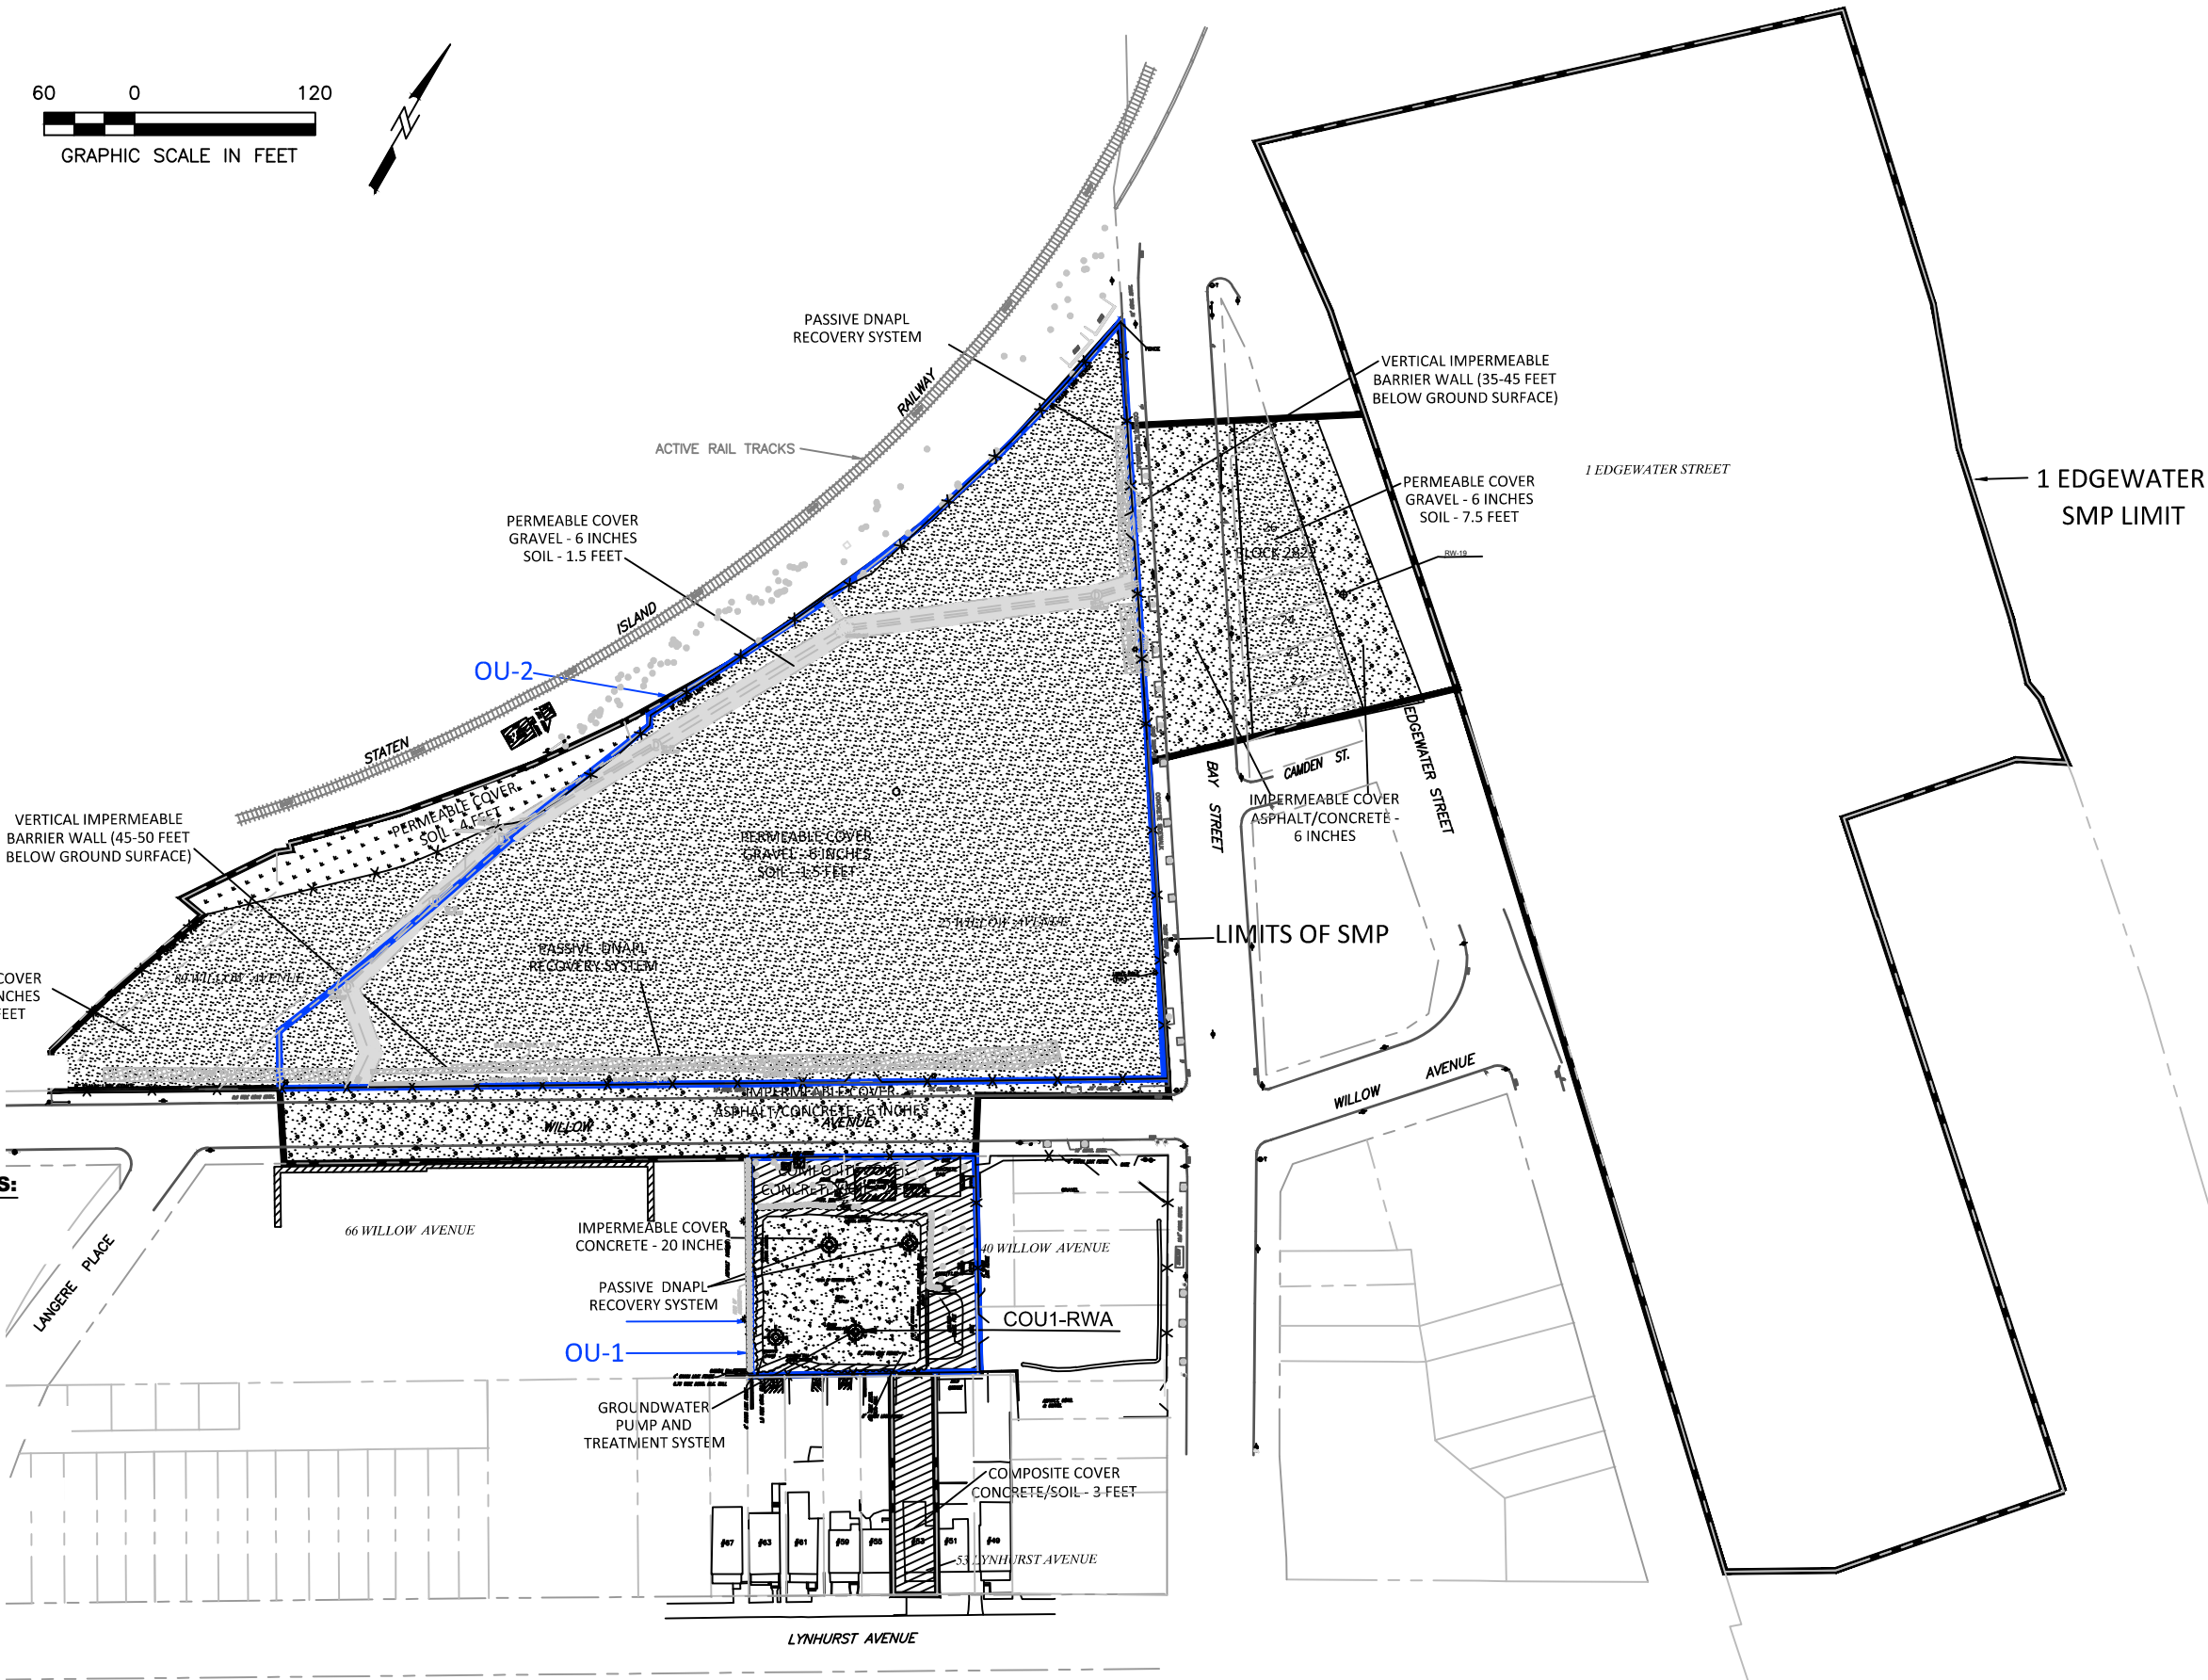
ENGINEERING CONTROL LOCATIONS

89 WILLOW AVENUE PROPERTY:

1. 2-Feet GRAVEL/SOIL COVER.
1. 4-Feet SOIL COVER.

- A soil cover system comprised of a minimum of 24-inches of clean fill placed over a portion of the Site (25 Willow Avenue) and off-Site areas (89 Willow Avenue); and
- A composite cover system comprised of a minimum of 6-inches of concrete cap, concrete foundations, soil, and/or asphalt placed on the Site (40 Willow Avenue) and off-Site areas (One Edgewater Street, 89 Willow Avenue, 53 Lyndhurst Avenue, properties east of 25 Willow Avenue, and New York City rights-of-way).

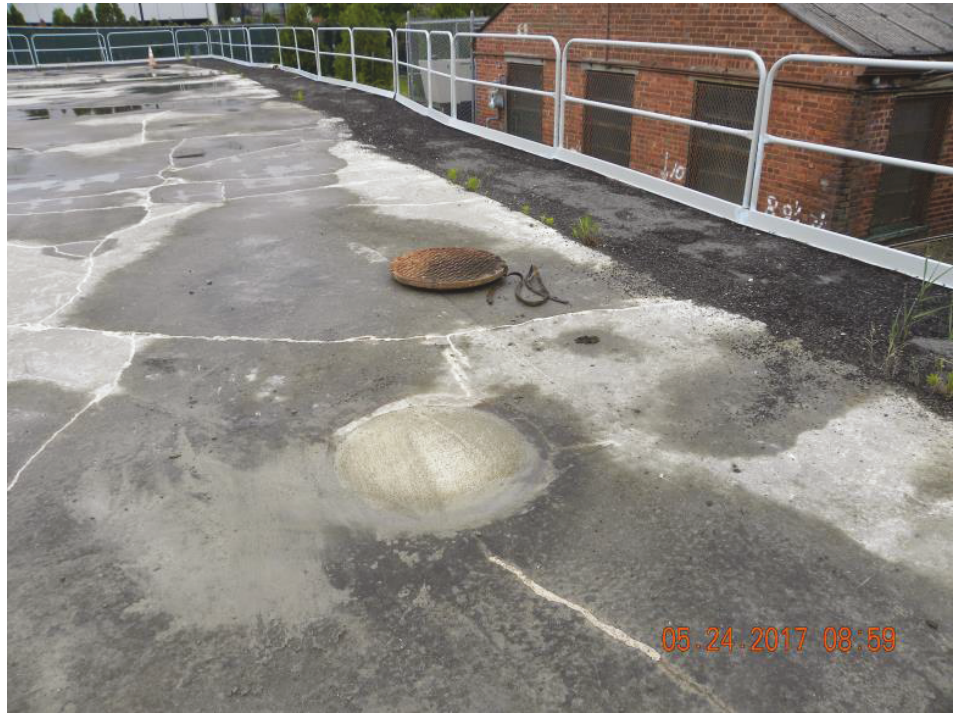
PROJECT NAME:
National Grid Clifton**PROJECT DESCRIPTION:**
Well Decommissioning**AECOM PROJECT:**
60137363**Photo No.**
1**Date:**
5/24/17**Description:***Well ID:* NE VWP*Photo Direction:* West

Close-up of concreted manhole containing NE VWP.

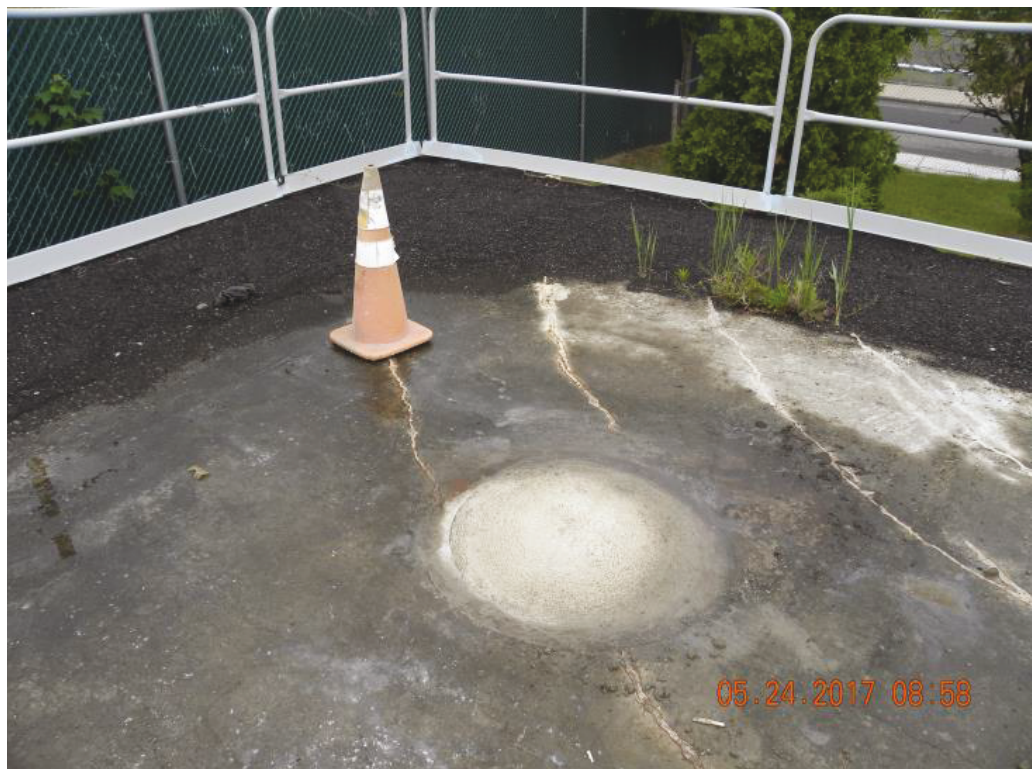
**Photo No.**
2**Date:**
5/24/17**Description:***Well IDs:* NW VWP &
WL-PZ-1*Photo Direction:* West

Close-up of concreted manhole containing NW VWP and WL-PZ-1.

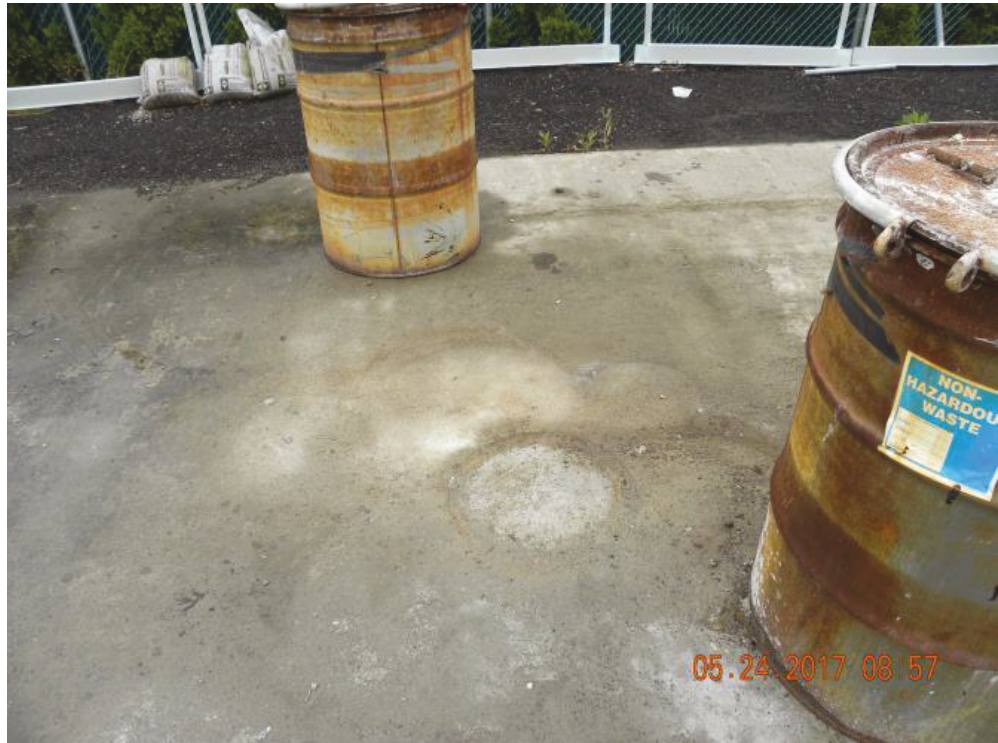
PROJECT NAME:
National Grid Clifton**PROJECT DESCRIPTION:**
Well Decommissioning**AECOM PROJECT:**
60137363**Photo No.**
3**Date:**
5/24/17**Description:***Well ID:* NRW-03D*Photo Direction:*
Southwest

Close-up of concreted roadbox from grouted NRW-03D. Drums contain bags of gravel that were used to support stick-up PVC.

- NRW-03D was decommissioned on May 22, 2017 through the application of bentonite chips inside the sump to immobilize remaining DNAPL which could not be recovered and to reduce artesian well conditions, and then tremie grouted. The manhole was concreted flush with the surrounding grade on the following day (May 23).

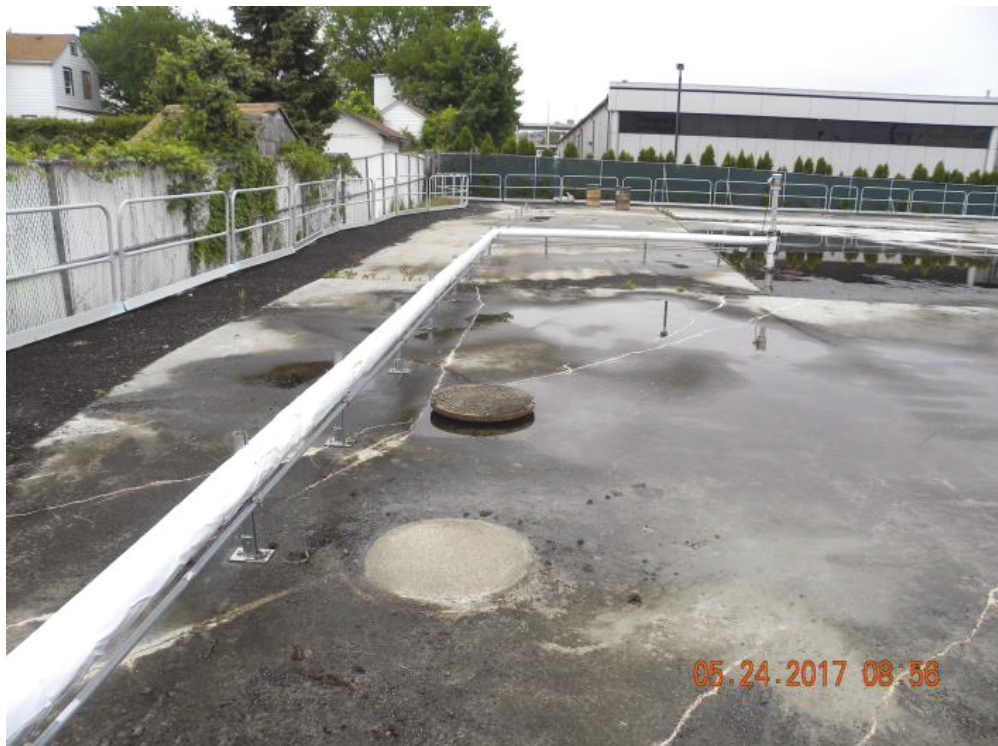
**Photo No.**
4**Date:**
5/24/17**Description:***Well ID:* SE VWP*Photo Direction:*
Southwest

Close-up of concreted manhole containing SE VWP.

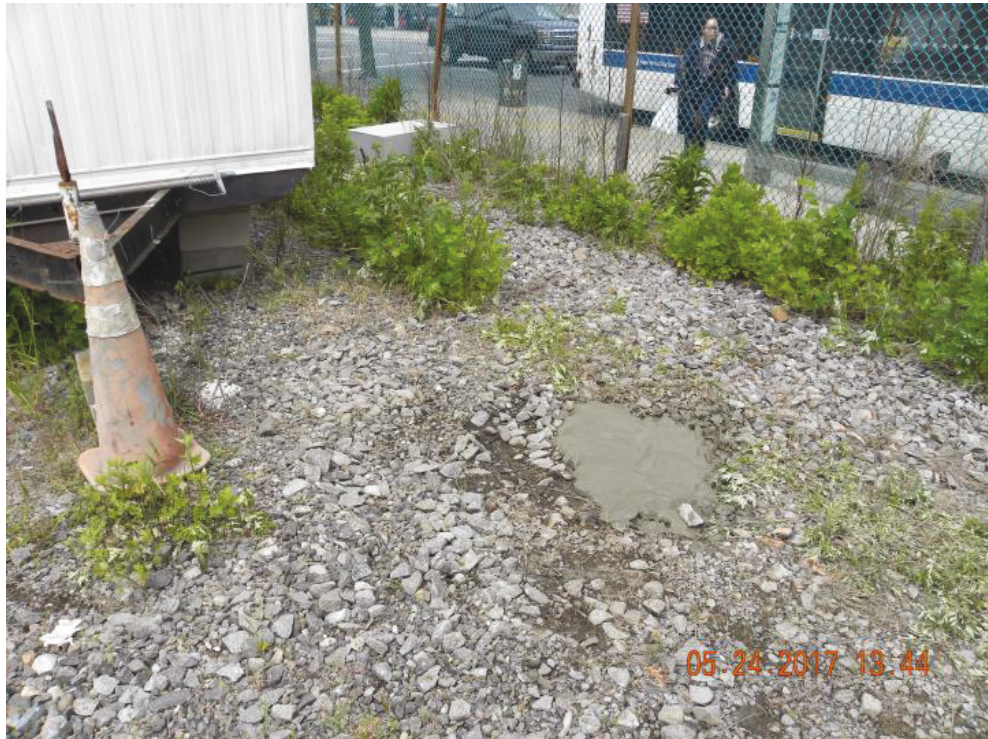
PROJECT NAME:
National Grid Clifton**PROJECT DESCRIPTION:**
Well Decommissioning**AECOM PROJECT:**
60137363**Photo No.**
5**Date:**
5/24/17**Description:***Well ID:* RW-04*Photo Direction:* NorthRW-04 was grouted,
roadbox removed, and
area concreted over.

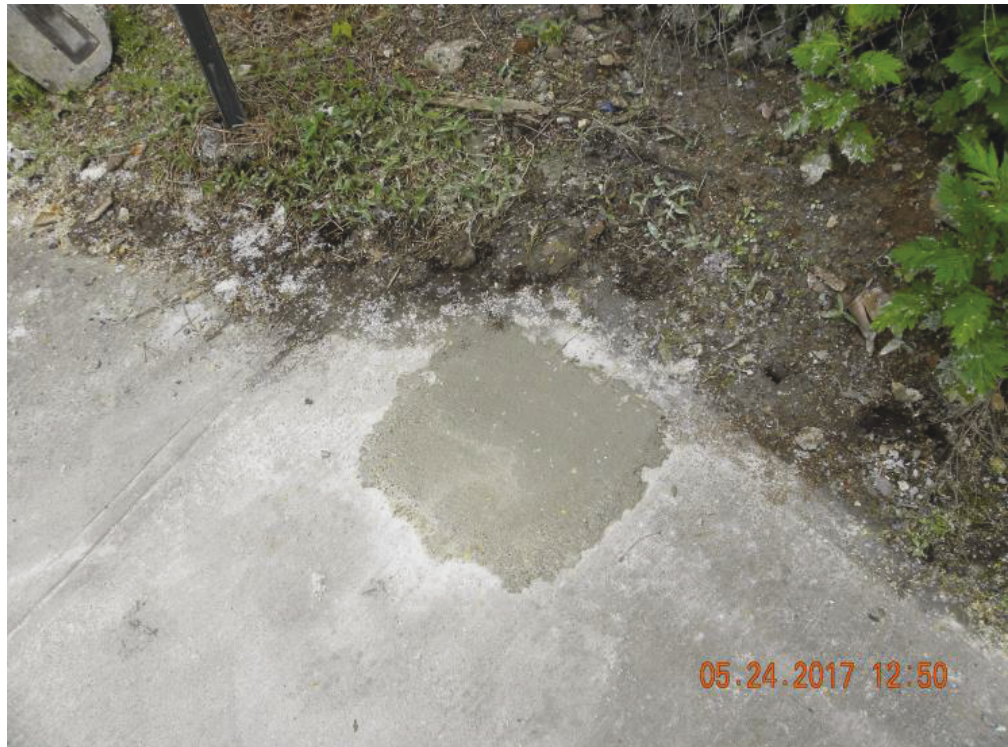
**Photo No.**
6**Date:**
5/24/17**Description:***Well ID:* RW-12*Photo Direction:*
SoutheastRW-12 was grouted
and roadbox removed.
The roadbox was
sawcut out of sidewalk
and the cut out area
was concreted.

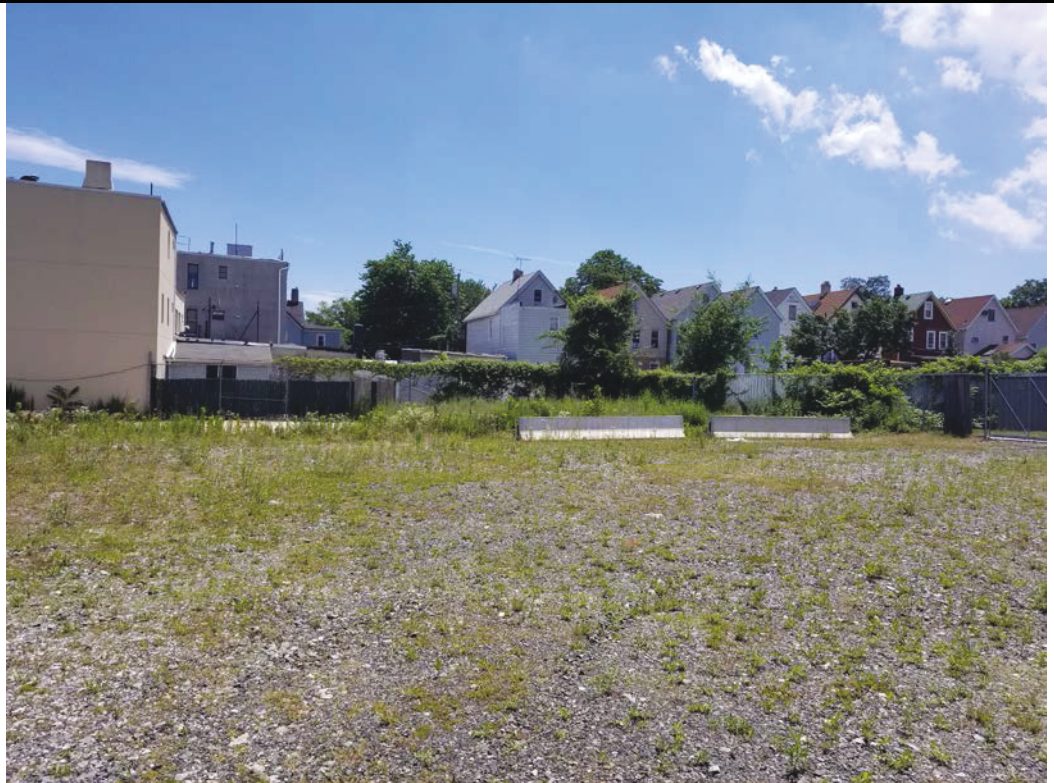
Southerly view into OU1
from the Willow Avenue
gate.

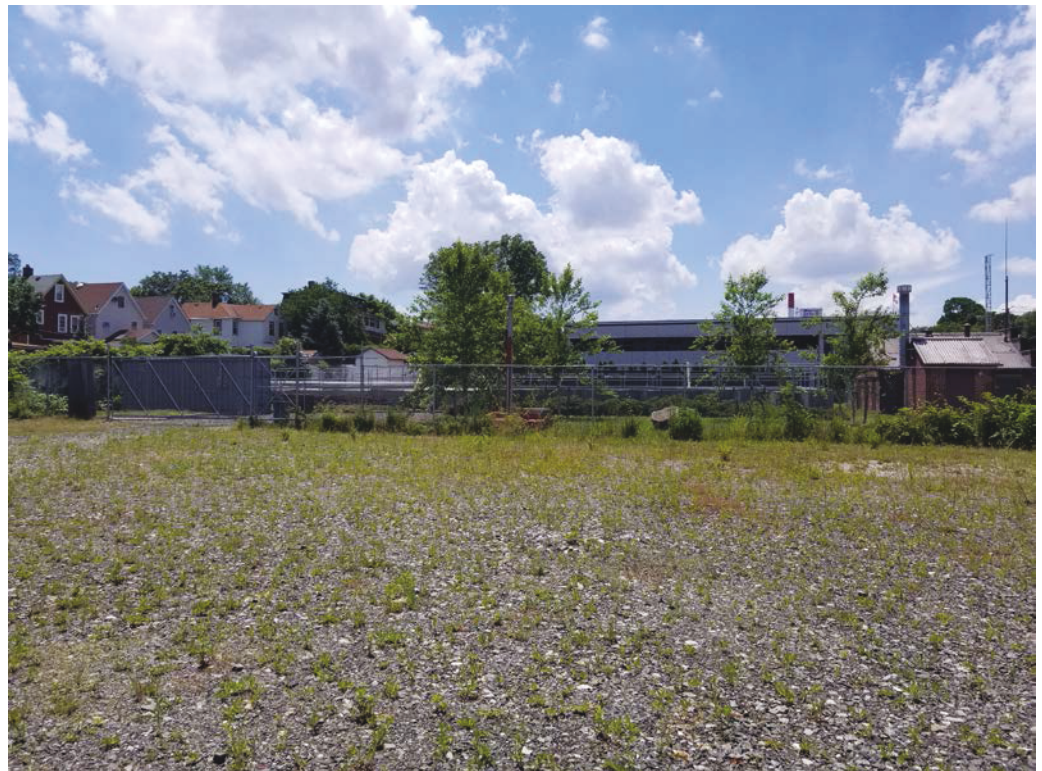
Photo No.
2

Westerly view into OU1
from the Willow Avenue
gate; the Containment
Pad is in the middle
background, and the
Depressurization System
treatment plant is in the
left background.

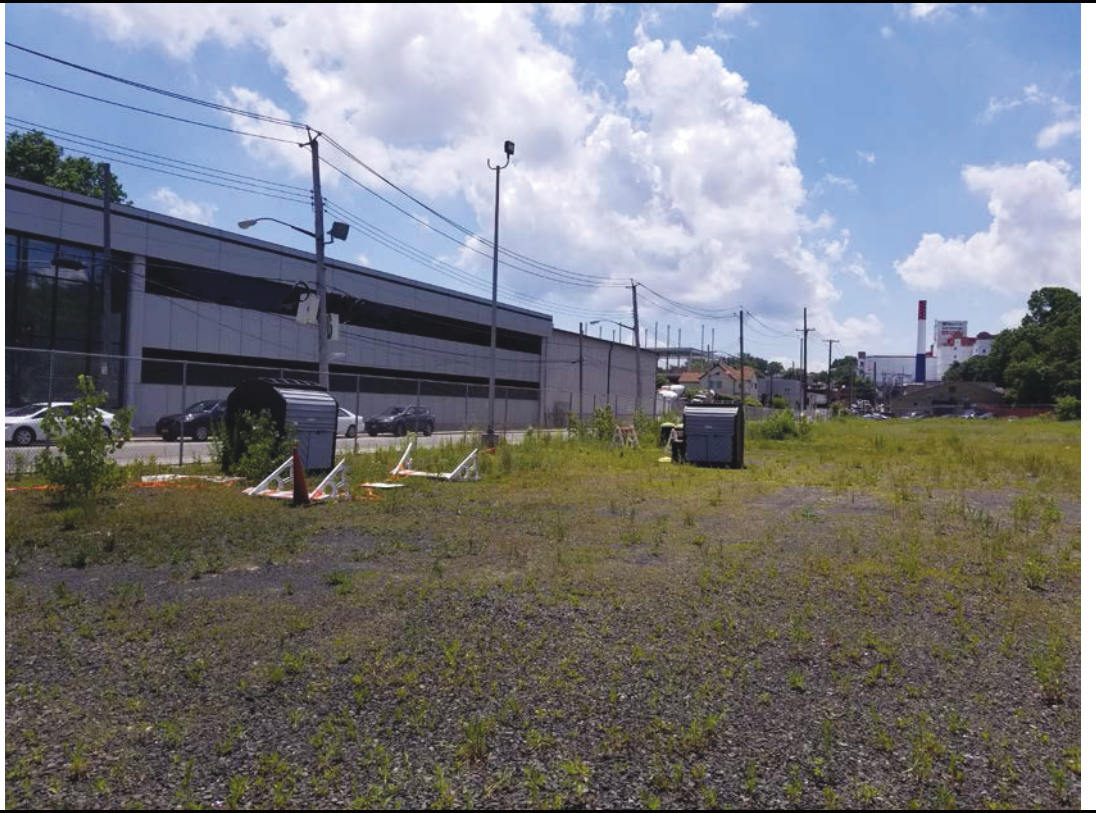
PROJECT NAME:
National Grid Clifton**PROJECT DESCRIPTION:**
Annual Site Inspection**AECOM PROJECT:**
60137363**Photo No.**
3**Date:**
6/27/17**Description:**

Westerly view along the property line of OU2 from the Willow Avenue gate. The subsurface DNAPL barrier wall is located inside the site fence, and a typical DNAPL recovery well vault can be seen in the left midground, between the barriers.

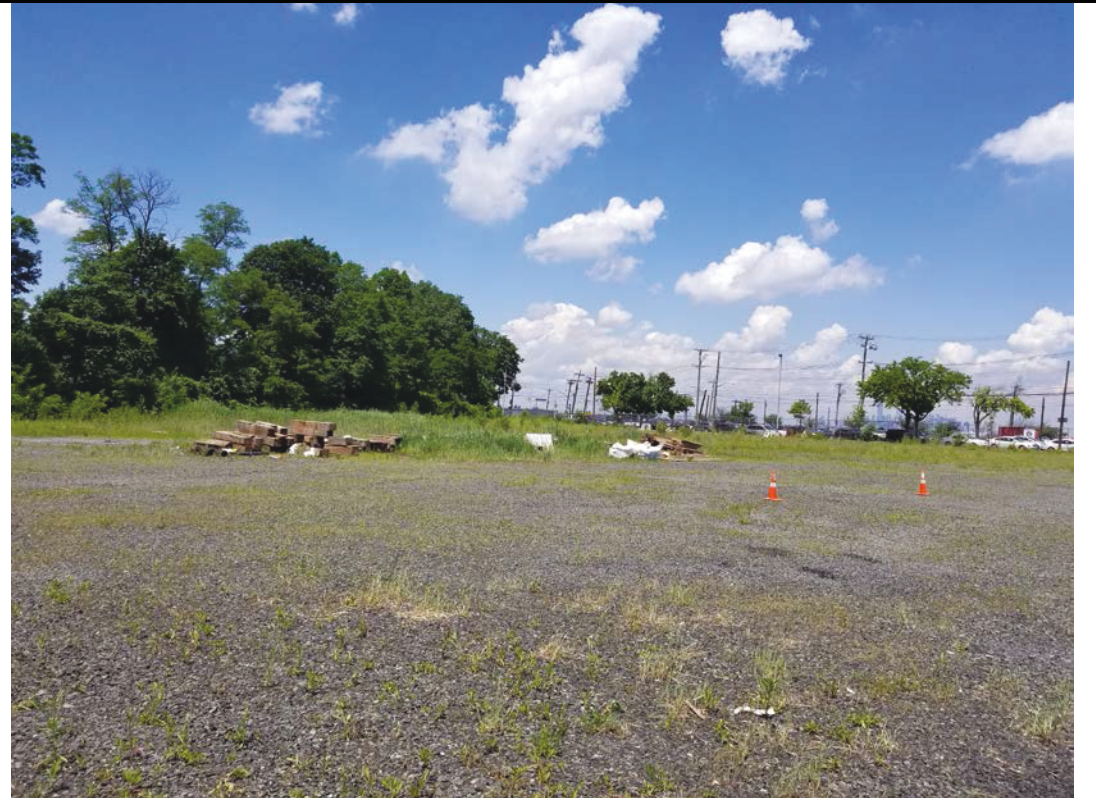
**Photo No.**
4**Date:**
6/27/17**Description:**

Northerly view into OU2 from the Willow Avenue gate.

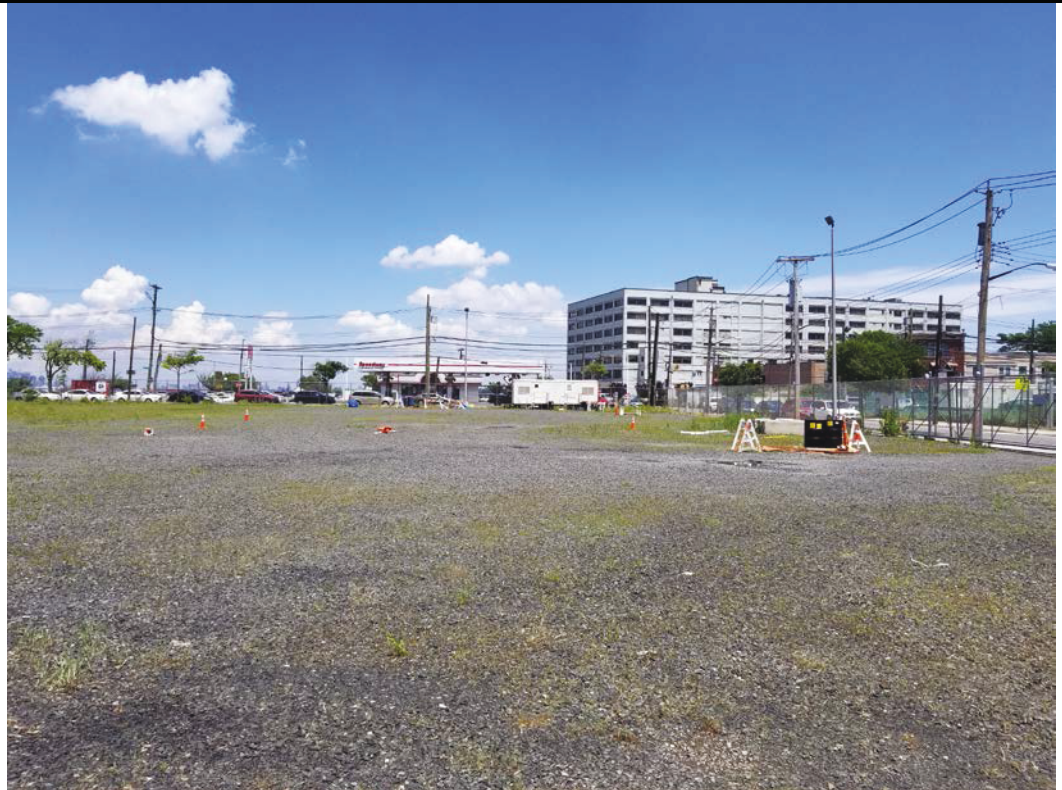
PROJECT NAME:
National Grid Clifton**PROJECT DESCRIPTION:**
Annual Site Inspection**AECOM PROJECT:**
60137363**Photo No.**
5**Date:**
6/27/17**Description:**

Easterly view along the property line of OU2 from the Willow Avenue gate. The subsurface DNAPL barrier wall is located inside the site fence, and a typical DNAPL recovery well vault can be seen in the right midground, between the barriers.

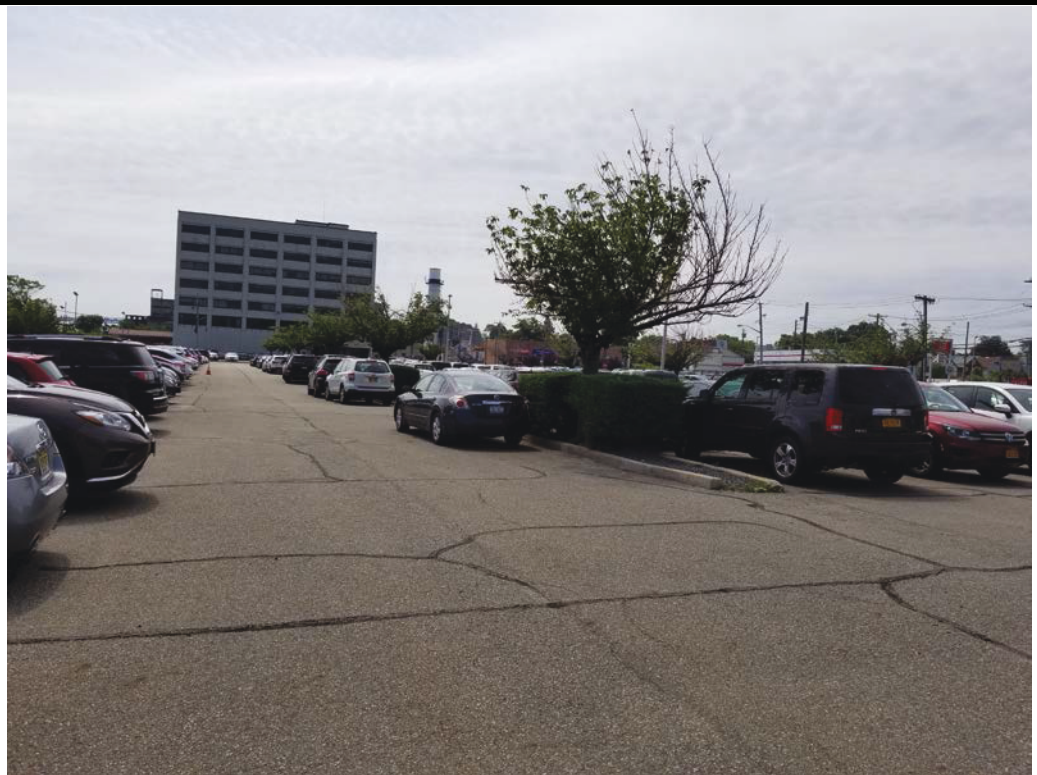
**Photo No.**
6**Date:**
7/5/17***Description:**

Typical view south into the One Edgewater Street property showing the composite cap system.

* Site was initially inspected on 6/27/17 but no pictures were taken; picture was taken on a subsequent return visit.

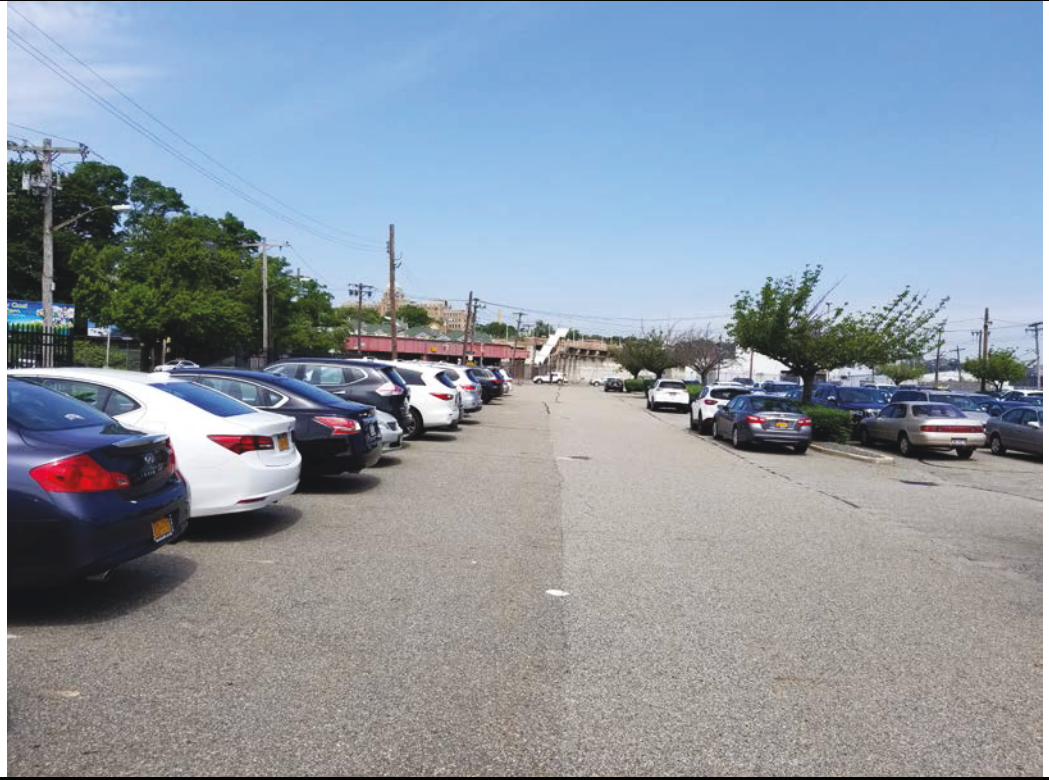
Typical view north into the One Edgewater Street property showing the composite cap system.

* Site was initially inspected on 6/27/17 but no pictures were taken; picture was taken on a subsequent return visit.
